# DIAGNOSING THROTTLE POSITION SENSOR INTERFERENCE IN ELECTRONIC CONTROL UNITS FOR AUTOMOTIVE VOCATIONAL EDUCATION

Intermittent sensor faults can produce unstable engine behavior while remaining difficult to detect through visual inspection or sparse static measurements. This study examined Throttle Position Sensor (TPS) interference, corrective action, and instructional implications for automotive vocational education. A single-vehicle experimental diagnostic case was conducted on a Daihatsu Xenia 1.0 Non-VVT-i with an EJ-DE engine. The procedure separated original-fault inspection, preliminary connector service, controlled interference replication, and post-repair verification. Original inspection identified resistive-track wear and mild oxidation of the VTA connector terminal. After preliminary connector cleaning and fastener retightening, three static TPS checkpoints remained within specification. Controlled replication then produced intermittent 0.3–4.8 V fluctuations at 45°–55°. During the diagnostic sequence, DTCs P0121, P0122, P0300, and P0171 and irregular TPS live-data behavior were recorded, while idle fluctuation of 550–950 rpm was explicitly observed during the interf

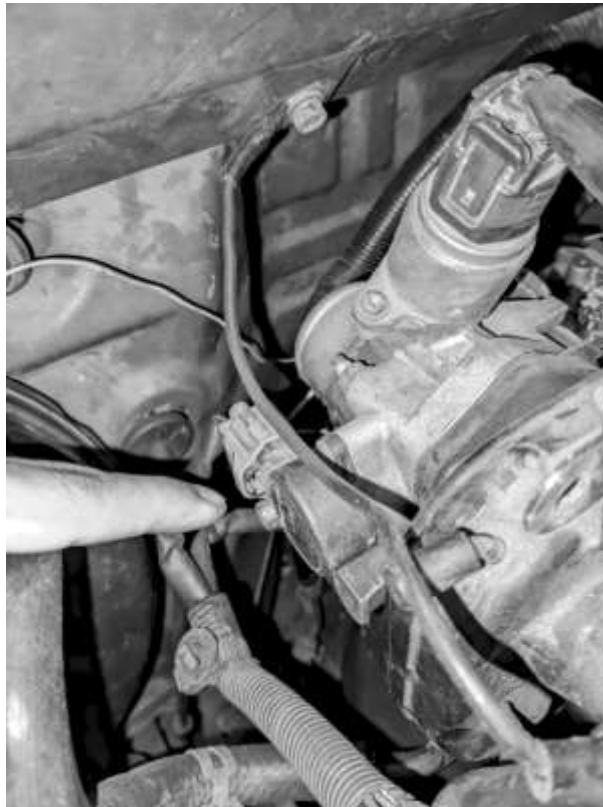
**Figure 3. Throttle Position Sensor (TPS) documented during inspection**

Physical inspection found no crack or obvious damage to the TPS housing. Mild oxidation was present on the VTA terminal and the terminal surface was slightly darkened. Inspection of the resistive track identified wear or scratching along the wiper-arm trajectory, while the throttle shaft itself moved smoothly without noticeable drag. The original narrative also recorded one TPS fastening bolt as slightly loose. These observations were relevant because they provided a physical basis for considering intermittent electrical contact, although none of the findings by itself establishes the complete causal chain between TPS degradation and all observed engine symptoms.

The TPS photograph retained from the diagnostic case is shown in Figure 3. The figure is used as component documentation rather than as proof of the microscopic electrical behavior of the resistive track; the latter requires electrical measurement. This distinction responds to the practical problem motivating the study: external appearance may be insufficient for diagnosing a contact-related fault that appears only over a particular portion of sensor travel.

Corrective action combined sensor replacement and connector service: the TPS unit was replaced, the connector terminal was cleaned, fastening hardware was tightened, TPS/ECU recalibration was performed through the reset procedure, and DTC memory was cleared before verification. After repair, the three retained voltage checkpoints were 0.55 V at idle, 2.02 V at half opening, and 4.35 V at WOT (Table 7), all within the reported service-manual ranges. Because post-repair data were retained only at these three points, the revised manuscript does not claim that a complete continuous voltage trace over every throttle angle was recorded after repair.
