# DIAGNOSING THROTTLE POSITION SENSOR INTERFERENCE IN ELECTRONIC CONTROL UNITS FOR AUTOMOTIVE VOCATIONAL EDUCATION

Intermittent sensor faults can produce unstable engine behavior while remaining difficult to detect through visual inspection or sparse static measurements. This study examined Throttle Position Sensor (TPS) interference, corrective action, and instructional implications for automotive vocational education. A single-vehicle experimental diagnostic case was conducted on a Daihatsu Xenia 1.0 Non-VVT-i with an EJ-DE engine. The procedure separated original-fault inspection, preliminary connector service, controlled interference replication, and post-repair verification. Original inspection identified resistive-track wear and mild oxidation of the VTA connector terminal. After preliminary connector cleaning and fastener retightening, three static TPS checkpoints remained within specification. Controlled replication then produced intermittent 0.3–4.8 V fluctuations at 45°–55°. During the diagnostic sequence, DTCs P0121, P0122, P0300, and P0171 and irregular TPS live-data behavior were recorded, while idle fluctuation of 550–950 rpm was explicitly observed during the interf

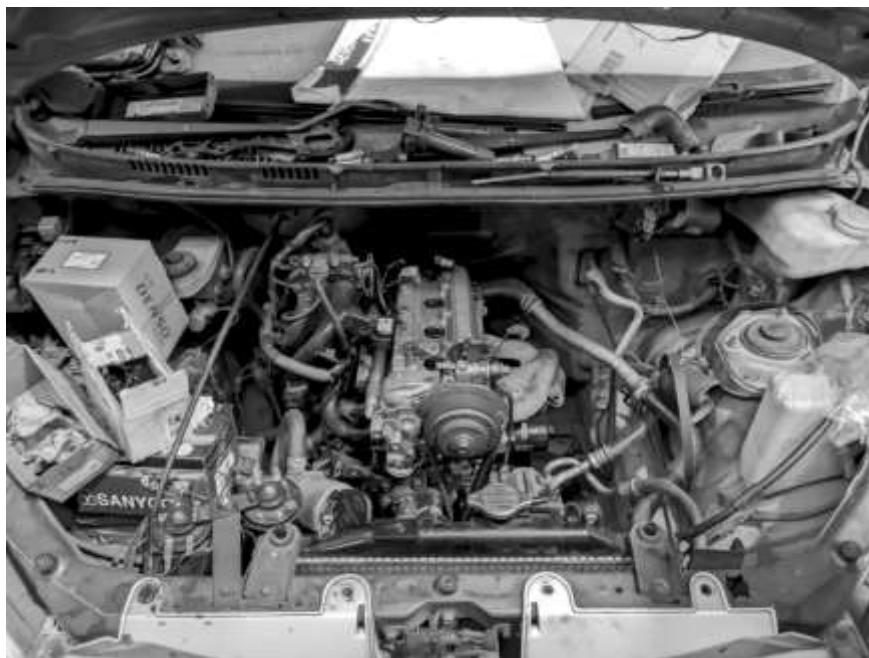
**Figure 2. Daihatsu Xenia 1.0 Non-VVT-i engine used in the diagnostic case**

Physical inspection found no crack or obvious damage to the TPS housing. Mild oxidation was present on the VTA terminal and the terminal surface was slightly darkened. Inspection of the resistive track identified wear or scratching along the wiper-arm trajectory, while the throttle shaft itself moved smoothly without noticeable drag. The original narrative also recorded one TPS fastening bolt as slightly loose. These observations were relevant because they provided a physical basis for considering intermittent electrical contact, although none of the findings by itself establishes the complete causal chain between TPS degradation and all observed engine symptoms.

After the physical inspection, the source record states that the connector terminal was cleaned and the slightly loose fastening bolt was retightened before the first three-point voltage check. At idle, half opening, and WOT, the measured values were 0.52 V, 1.98 V, and 4.31 V, respectively, all within the reported reference ranges (Table 3). The provenance of these data is therefore important: they represent limited checkpoints after preliminary connector service but before the deliberate interference replication and before TPS replacement. Their normal appearance shows why a sparse static test can fail to capture an intermittent defect, but it cannot
